## Appendix A14.1

### Scheme Walkover Summary

## Appendix A14.1: Scheme Walkover Summary

The following is a summary of the observations by the Land, Soils, Geology and Hydrogeology Environmental Impact Assessment Team following a physical walkover of the Proposed Scheme. The walkover occurred on 20 February 2020 and 31 January 2022.

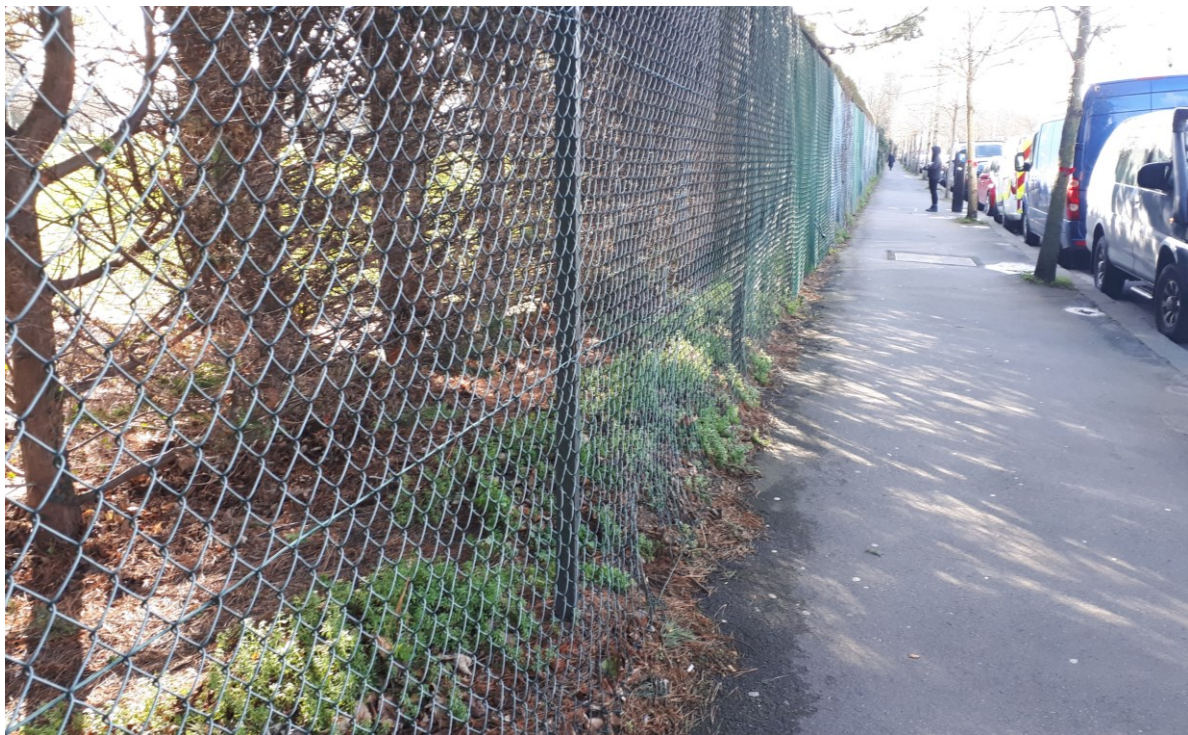
| Observation | General Arrangement (GA) Drawing Sheet Number (refer to Volume 3 of the EIAR for GA drawings) | Description | Possible Impact | Photo Number |
|---|---|---|---|---|
| Nutley Lane proposed road widening | Sheets 22 to 23 | Proposed widening of the road along Nutley Lane along the boundary of Elm Park Golf & Sports Club near St. Vincent's University Hospital. | This may pose an issue for the earthworks balance and waste assessment. | Belfield Black_Image_01 |

| Photo ID | Caption | Date Taken | Coordinates |
|---|---|---|---|
| Belfield Black_Image_01 | Nutley Lane proposed road widening along the Elm Park Golf & Sports Club boundary near St. Vincent's University Hospital | 20/02/2020 | 718762,731067 (ITM) |

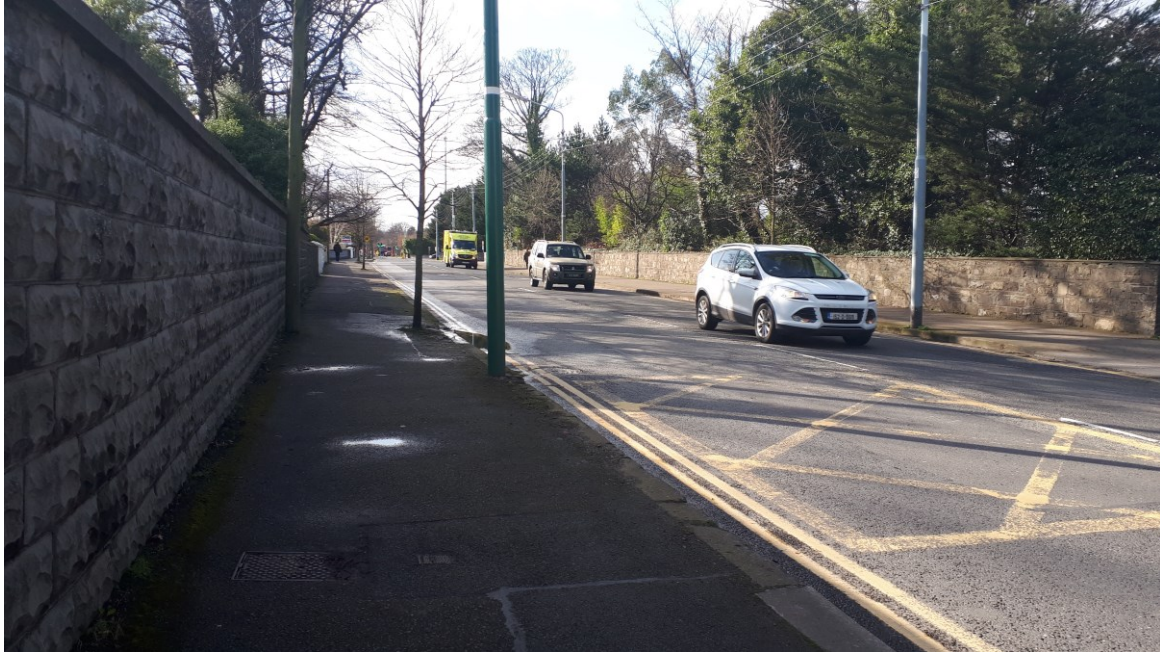
| Observation | General Arrangement (GA) Drawing Sheet Number (refer to Volume 3 of the EIAR for GA drawings) | Description | Possible Impact | Photo Number |
|---|---|---|---|---|
| Nutley Lane proposed road widening | Sheet 22 | Proposed widening of the road along Nutley Lane between the entrance of Elm Park Golf & Sports Club and RTE studios. | This may pose an issue for the earthworks balance and waste assessment. | Belfield Black_Image_02 |

| Photo ID | Caption | Date Taken | Coordinates |
|---|---|---|---|
| Belfield Black_Image_02 | Proposed widening of the road along Nutley Lane between the entrance of Elm Park Golf & Sports Club and RTE studios | 20/02/2020 | 718605,730912 (ITM) |

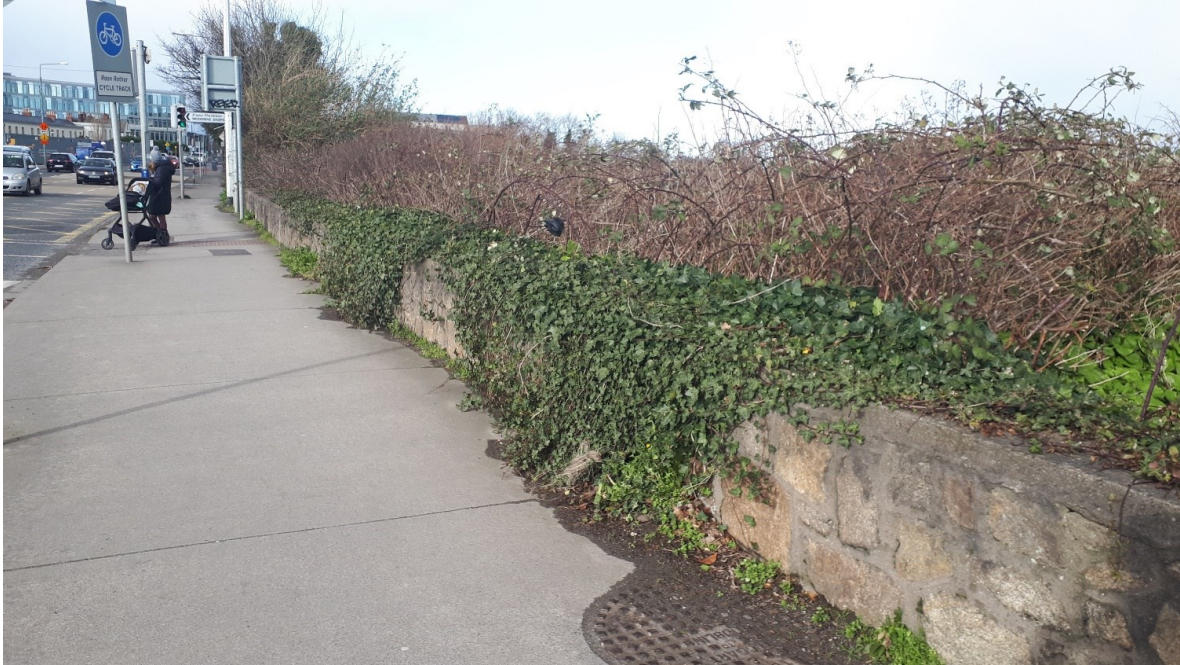
| Observation | General Arrangement (GA) Drawing Sheet Number (refer to Volume 3 of the EIAR for GA drawings) | Description | Possible Impact | Photo Number |
|---|---|---|---|---|
| Booterstown Marsh | Sheets 8 to 9 | Approximately 40m of new boundary wall is proposed to be set back into the proposed Natural Heritage Areas (pNHA). | This may pose an issue for the earthworks balance and waste assessment and the possibility of mobilising contaminants into the pNHA | Belfield Black_Image_03 |

| Photo ID | Caption | Date Taken | Coordinates |
|---|---|---|---|
| Belfield Black_Image_03 | It is proposed to widen the road at the north western section adjacent to the Booterstown Marsh (pNHA) where retaining walls are present. | 20/02/2020 | 719864,730611 (ITM) |

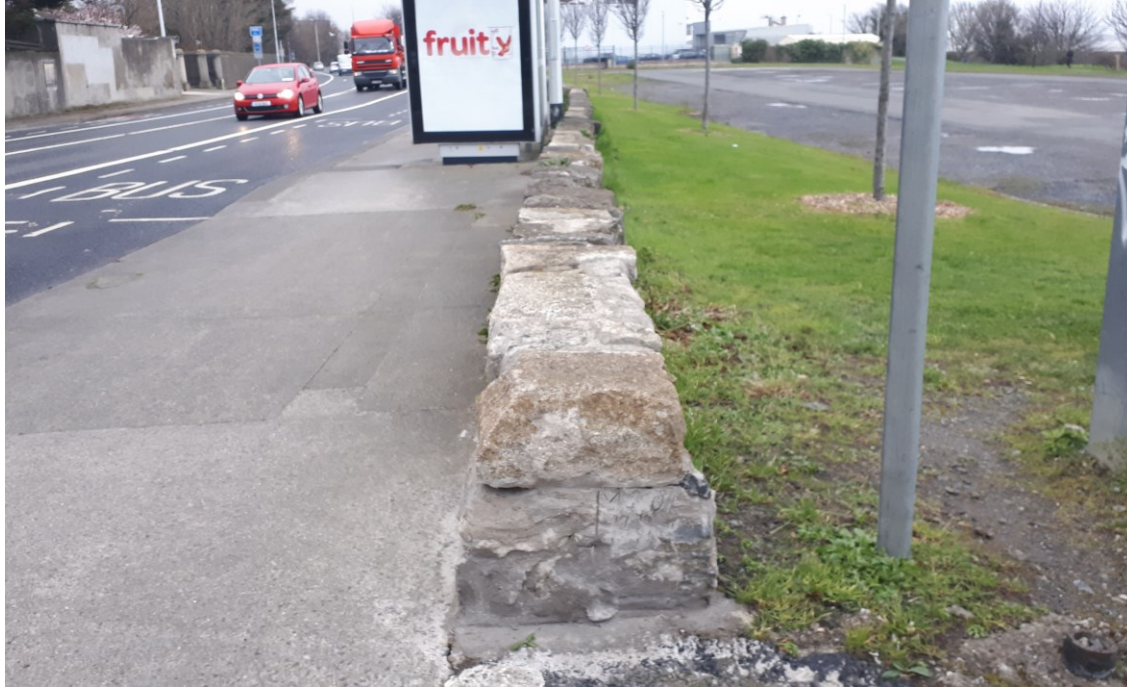
| Observation | General Arrangement (GA) Drawing Sheet Number (refer to Volume 3 of the EIAR for GA drawings) | Description | Possible Impact | Photo Number |
|---|---|---|---|---|
| Location of a construction compound along Rock Road | Sheet 6 | A construction compound is to be located in Booterstown Car Park, within Blackrock Park, along the R118, opposite Willow Terrace. | This may pose an issue for the earthworks balance and waste assessment. | Belfield Black_Image_04 |

| Photo ID | Caption | Date Taken | Coordinates |
|---|---|---|---|
| Belfield Black_Image_04 | Proposed location of a potential construction compound along the Rock Road | 20/02/2020 | 720983,729683 (ITM) |

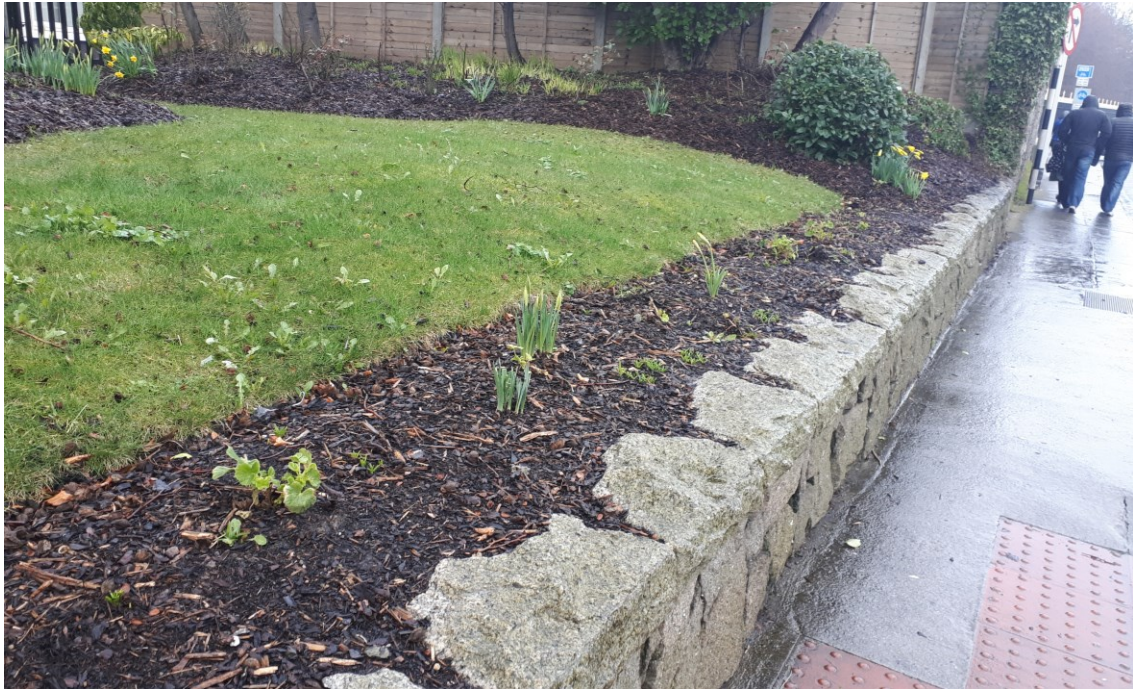
| Observation | General Arrangement (GA) Drawing Sheet Number (refer to Volume 3 of the EIAR for GA drawings) | Description | Possible Impact | Photo Number |
|---|---|---|---|---|
| Rock Road | Sheets 4 to 5 | Proposed widening of the scheme along the Rock Road near the Blackrock Clinic where minor level changes were noted | This may pose an issue for the earthworks balance and waste assessment. | Belfield Black_Image_05 |

| Photo ID | Caption | Date Taken | Coordinates |
|---|---|---|---|
| Belfield Black_Image_05 | Proposed widening of the scheme along the Rock Road near the Blackrock Clinic where minor level changes were noted | 20/02/2020 | 720770,729826 (ITM) |

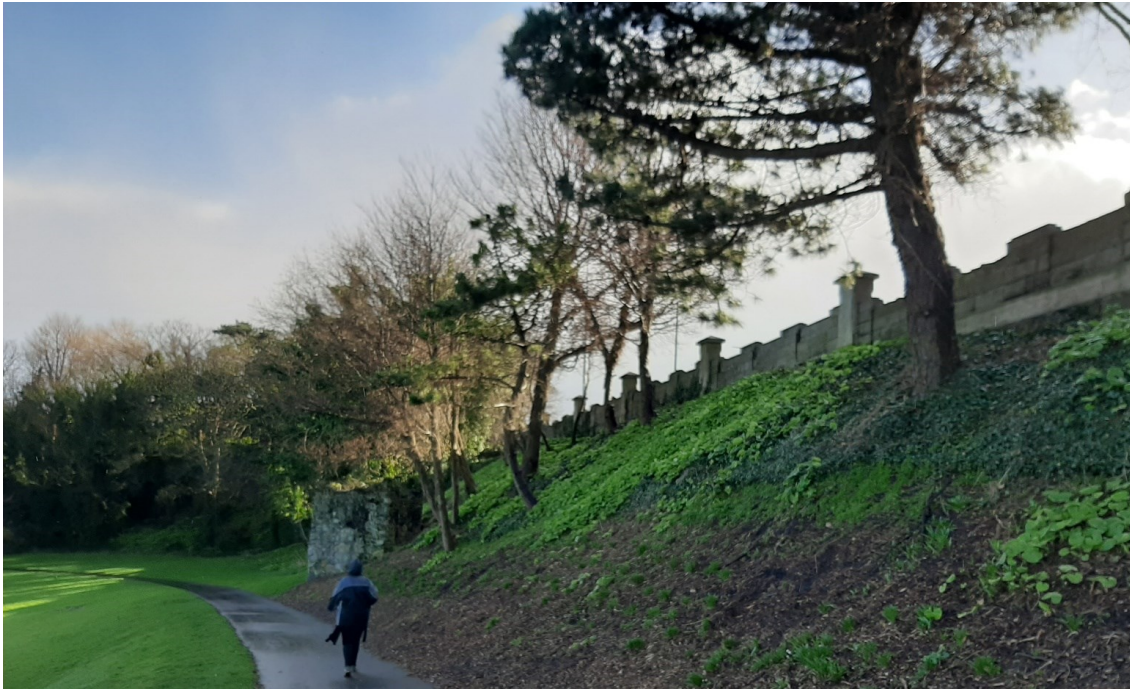
| Observation | General Arrangement (GA) Drawing Sheet Number (refer to Volume 3 of the EIAR for GA drawings) | Description | Possible Impact | Photo Number |
|---|---|---|---|---|
| Rock Road | Sheets 4 to 5 | Proposed widening of the scheme along the Rock Road where significant level changes are observed of up to 5m within Blackrock Park | This may pose an issue for the earthworks balance and waste assessment. | Belfield Black_Image_06 |

| Photo ID | Caption | Date Taken | Coordinates |
|---|---|---|---|
| Belfield Black_Image_06 | Proposed widening of the scheme along the Rock Road where significant level changes are observed of up to 5 m within Blackrock Park | 20/02/2020 | 720983,729683 (ITM) |

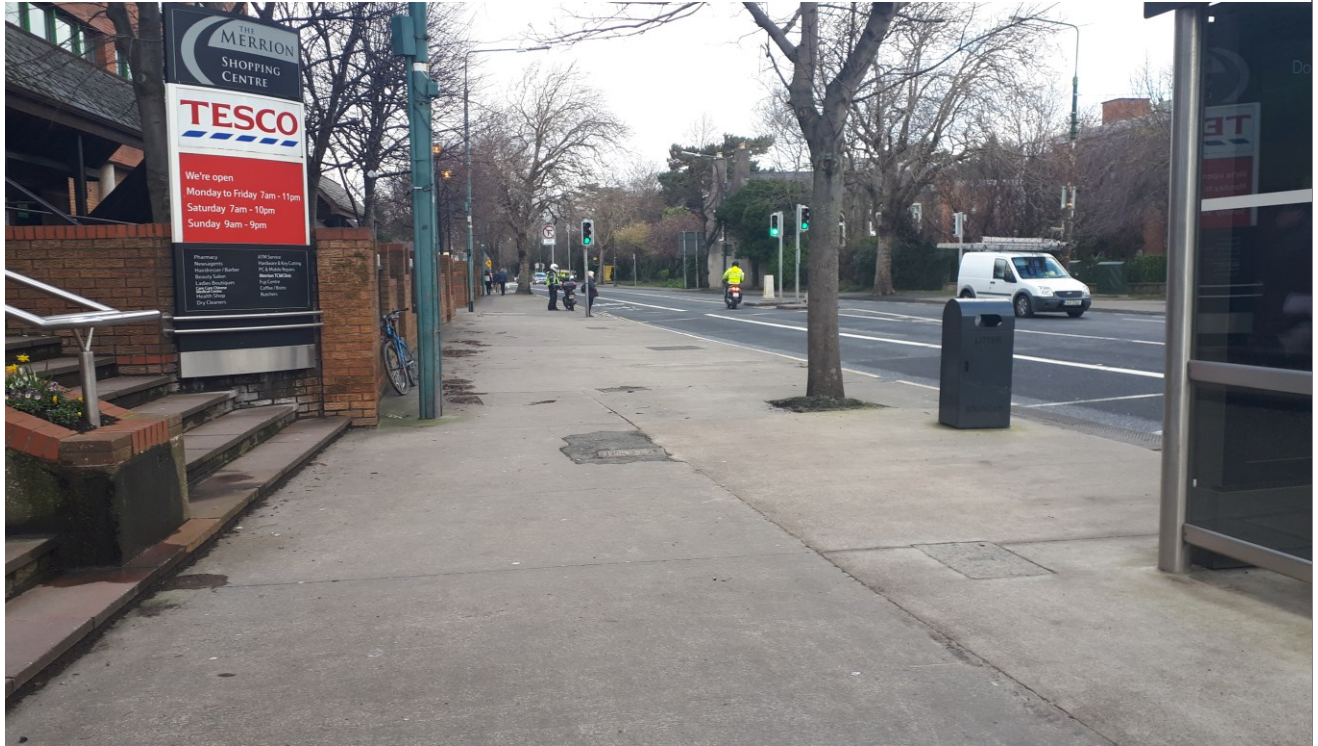
| Observation | General Arrangement (GA) Drawing Sheet Number (refer to Volume 3 of the EIAR for GA drawings) | Description | Possible Impact | Photo Number |
|---|---|---|---|---|
| Land Boundary, Merrion Shopping Centre | Sheet 12 | Proposed widening of the scheme outside the Merrion Shopping Centre | This may pose an issue for the earthworks balance and waste assessment. | Belfield Black_Image_07 |

| Photo ID | Caption | Date Taken | Coordinates |
|---|---|---|---|
| Belfield Black_Image_07 | Land boundary near Merrion Shopping Centre | 20/02/2020 | 720983,729683 (ITM) |

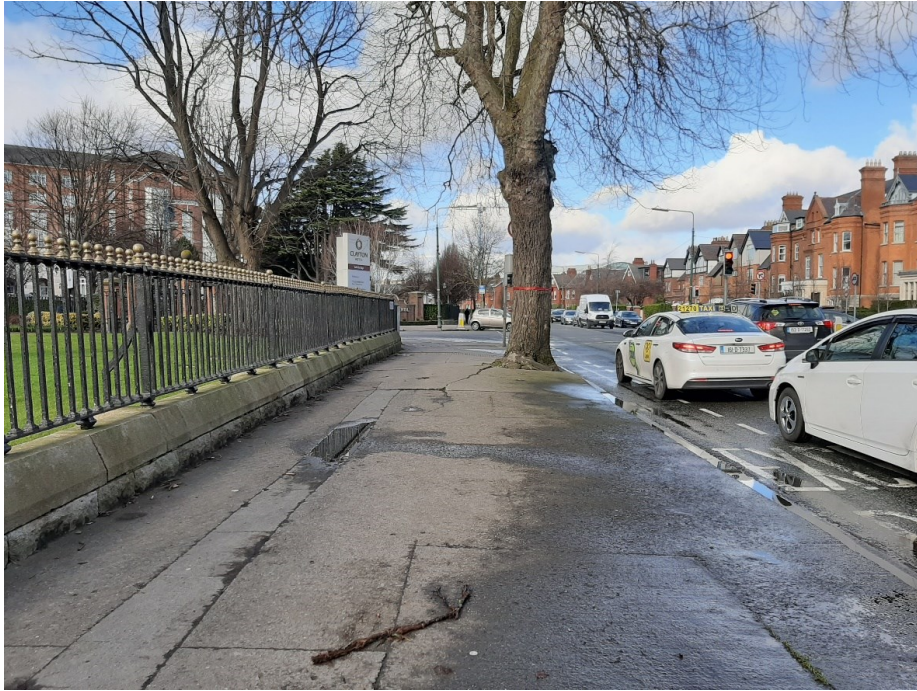
| Observation | General Arrangement (GA) Drawing Sheet Number (refer to Volume 3 of the EIAR for GA drawings) | Description | Possible Impact | Photo Number |
|---|---|---|---|---|
| Land boundary, Clayton Hotel Ballsbridge | Sheet 15 | Proposed widening along this section of the scheme near the Clayton Hotel Ballsbridge. Boundary walls may need to be removed and topsoil stripped to accommodate the works. | This may pose an issue for the earthworks balance and waste assessment. | Belfield Black_Image_08 |

| Photo ID | Caption | Date Taken | Coordinates |
|---|---|---|---|
| Belfield Black_Image_08 | Land boundary at the Clayton Hotel, Ballsbridge | 20/02/2020 | 720983,729683 (ITM) |

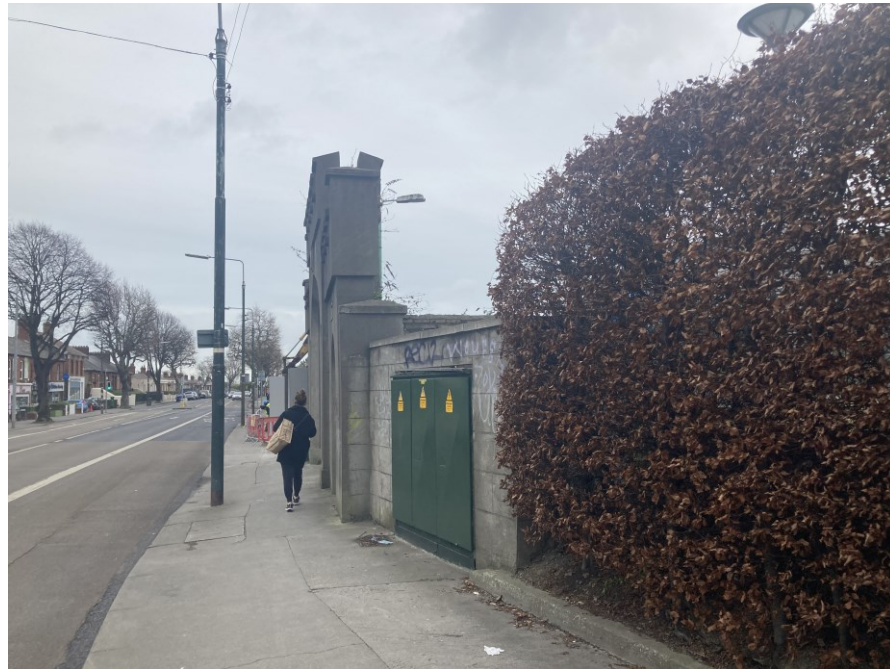
| Observation | General Arrangement (GA) Drawing Sheet Number (refer to Volume 3 of the EIAR for GA drawings) | Description | Possible Impact | Photo Number |
|---|---|---|---|---|
| Land Boundary Herbert Avenue | Sheet 11 | Proposed Road widening between Herbert Avenue and St. Vincent's University Hospital | This may pose an issue for the earthworks balance and waste assessment. | Belfield Black_Image_09 |

| Photo ID | Caption | Date Taken | Coordinates |
|---|---|---|---|
| Belfield Black_Image_09 | Proposed Road widening between Herbert Avenue and St. Vincent's University Hospital | 31/01/2022 | 719329,731191 (ITM) |

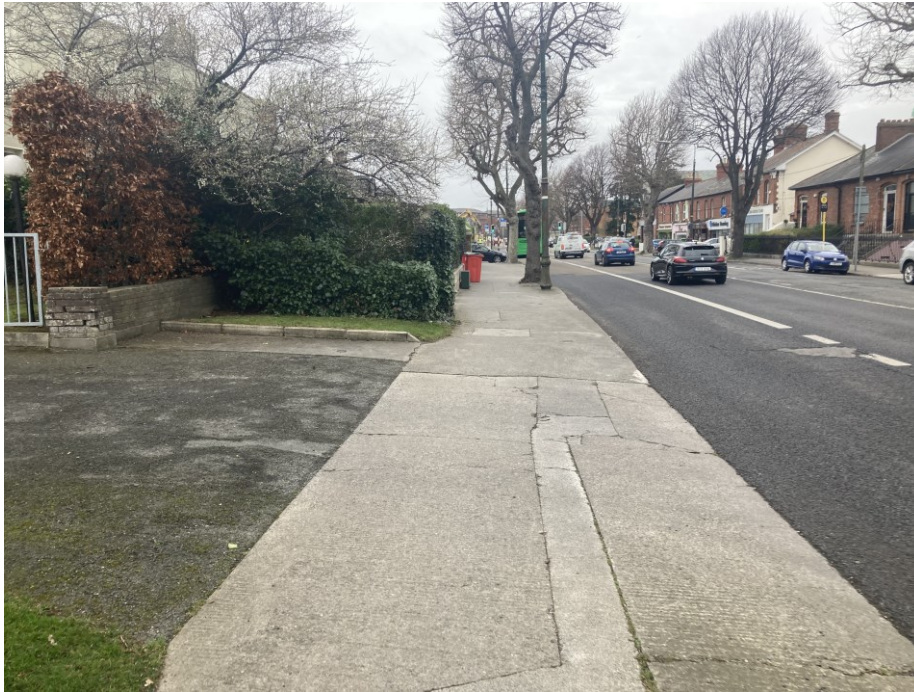
| Observation | General Arrangement (GA) Drawing Sheet Number (refer to Volume 3 of the EIAR for GA drawings) | Description | Possible Impact | Photo Number |
|---|---|---|---|---|
| Land Boundary Estate Avenue | Sheet 10 | Proposed Road widening outside Estate Avenue | This may pose an issue for the earthworks balance and waste assessment. | Belfield Black_Image_10 |

| Photo ID | Caption | Date Taken | Coordinates |
|---|---|---|---|
| Belfield Black_Image_10 | Proposed Road widening outside Estate Avenue | 31/01/2022 | 719457,731126 (ITM) |

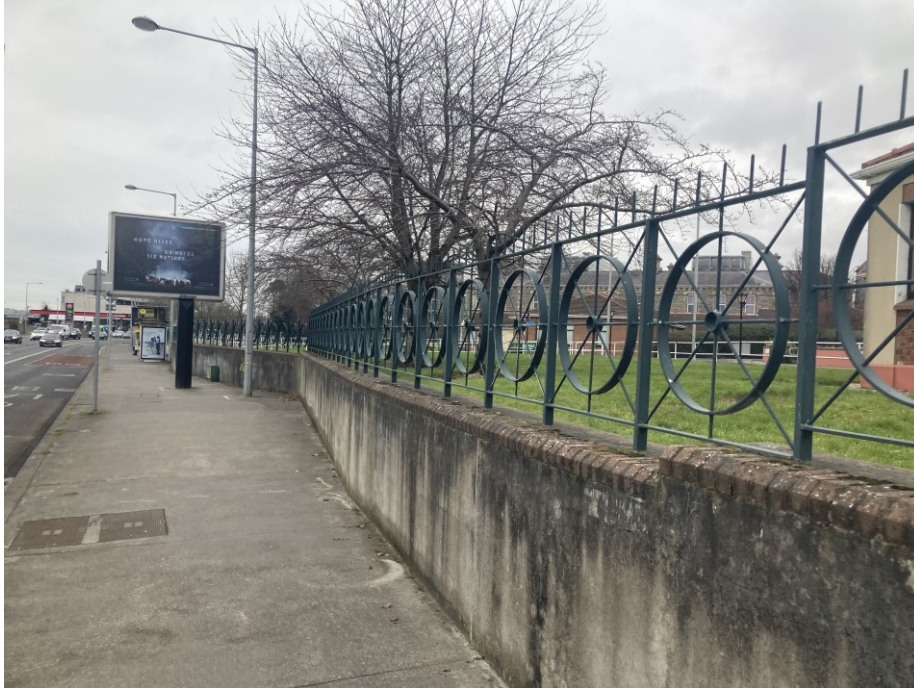
| Observation | General Arrangement (GA) Drawing Sheet Number (refer to Volume 3 of the EIAR for GA drawings) | Description | Possible Impact | Photo Number |
|---|---|---|---|---|
| Land Boundary opposite strand road | Sheet 10 | Proposed removal of existing boundary for road widening opposite Strand Road | This may pose an issue for the earthworks balance and waste assessment. | Belfield Black_Image_11 |

| Photo ID | Caption | Date Taken | Coordinates |
|---|---|---|---|
| Belfield Black_Image_11 | Proposed removal of existing boundary for road widening opposite the Strand Road | 31/01/2022 | 719569,731044 (ITM) |
