**BusConnects Core Bus Corridors  
- Belfield / Blackrock to City  
Centre Core Bus Corridor**

**Stage 1 Road Safety Audit**

Document Ref: P20-138-PSW3-RP-001

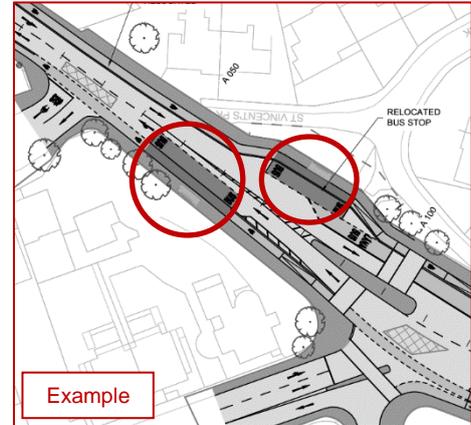
*Location: General Problem - Throughout the Scheme*

*Summary: Potential for cyclist/pedestrian collisions where cyclists approach the bus stop when passengers are boarding/d disembarking.*

The proposed arrangement for the cycle tracks at a number of the bus stops involves bringing cyclists up to the same level as the footpath, and widening the footpath out to the bus cage, with cyclists occupying the same space where passengers are boarding and disembarking.

Where bus frequencies are moderate to high (as would be expected on a Core Bus Corridor), and/or where cyclist volumes are moderate to high, this could lead to a risk of a cyclist striking a disembarking passenger, who would not expect to have a cyclist approaching alongside the stationary bus.

Review the proposed cycletrack layout at bus stops, in particular the expected volumes of cyclists and buses, and where necessary amend the arrangements to reduce/remove the likelihood of collisions between cyclists and embarking/d disembarking passengers.

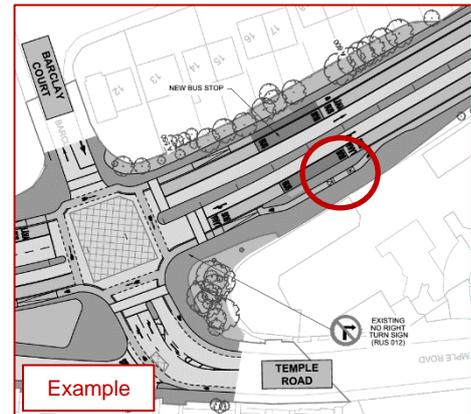
*Summary: Potential for cyclist/pedestrian collisions where bus passengers are required to cross the cycle track when accessing/leaving the floating/island bus stops.*

At some locations a footpath link is indicated between a bus stop and the adjacent footpath, with pedestrians & cyclists occupying the same space for a short distance.

At this early stage in the design process no tactile paving (either warning or guidance) has yet been indicated. Should insufficient guidance be provided at the shared surfaces between island bus stops and the adjacent footpath, this could result in an increased risk of collisions between cyclists and pedestrians where cyclists may be insufficiently aware of the shared area and of the need to moderate their speed, or even come to a halt.

An absence of Guidance Tactile Paving could result in increased difficulties for the visually impaired who may be unaware of how to access or leave the bus stop island.

Guidance Tactile Paving should be provided to guide visually impaired pedestrians to/from the footpath & the bus stop island.

Measures should be provided on the cycle track approaches to these footpath links, for example Ladder & Tramline tactile paving & Yield road markings, so that cyclists are aware that they are approaching a footpath crossing and that they should slow down & yield to pedestrians at these locations.

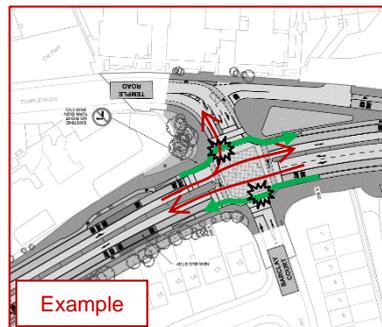
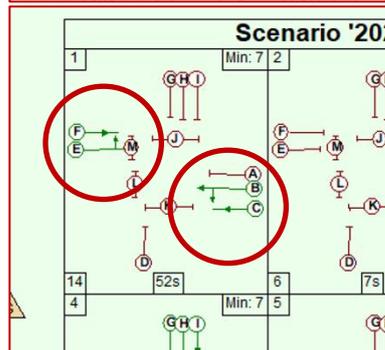
*Summary:* Left turning manoeuvres are indicated during the same signal phase as straight-ahead cyclists where turning drivers may be insufficiently aware of a cyclist proceeding straight at a number of the protected intersections/junctions within the Scheme.

There is a risk that drivers, when given a green signal, may not anticipate a straight-through cyclist to proceed simultaneously. This could arise where a left-turning driver misinterprets the layout as a signalised/toucan crossing on a separate phase, or where a stationary bus at the stop line in the bus lane between the traffic lane and the cycle lane obscures a left-turning driver's view of a cyclist on the cycle lane, and vice versa.

Additionally, left turning drivers may also turn across the path of a bus in the bus lane, leading to side-on collisions.

Reduce the lateral displacement of the straight through cycle lane from the left-turning traffic lane(s) to improve driver's awareness of possible straight through cyclists (e.g. amending the bus lane to also accommodate left-turning traffic on the immediate approach to the signals) and amend the left turn signals so that left turns are on a flashing amber.

This recommendation would also reduce the risk of left turning traffic moving in front of straight-ahead buses.

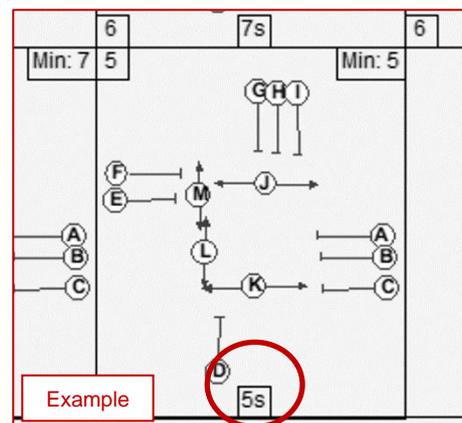
*Summary:* The timing proposed for pedestrian phases at a number of signalised junctions within the Scheme may not be sufficient to allow pedestrians, and in particular the mobility impaired, to complete a crossing safely.

At a number of signalised junctions within the Scheme, pedestrian phases have been indicated as being quite short (e.g. 5 seconds long). The Audit Team are concerned that this will not be sufficient time for non-motorised road-users, in particular the elderly & mobility impaired, to complete a crossing safely.

This could lead to pedestrians remaining within the carriageway when a subsequent green vehicular phase has been triggered increasing the risk of vehicle-pedestrian collisions.

Ensure pedestrian green phases are of a sufficient length such that all non-motorised road users can complete the crossing safely.

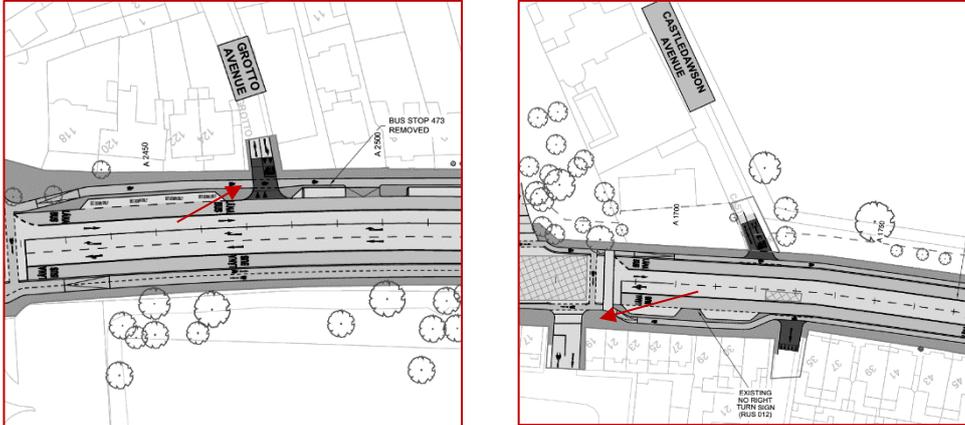
*Location:* BCIDC-ARP-GEO\_GA-1415\_XX\_01-DR-CR-0005 (Rev L01) and BCIDC-ARP-GEO\_GA-1415\_XX\_01-DR-CR-0007 (Rev L01)

*Summary:* Visibility (to cyclists/pedestrians) for drivers turning left into a side road may be impeded by vehicles parked in the parallel parking bays, leading to vehicle/pedestrian and vehicle/cyclist collisions.

Vehicles occupying parking areas or set-down areas may block visibility towards cyclists and pedestrians on the footway, resulting in possible vehicle/pedestrian and vehicle/cyclist collisions when traffic turns left into the respective side road.

Ensure sufficient inter-visibility between drivers and pedestrians/cyclists is provided at these locations.

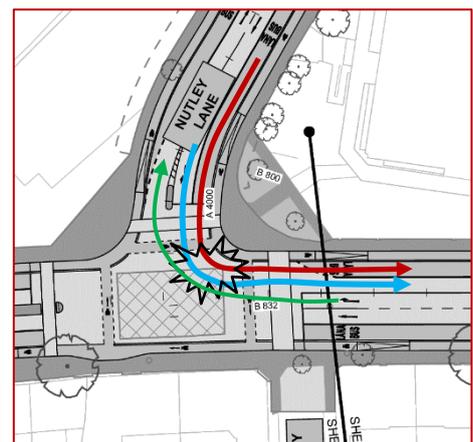
*Location:* BCIDC-ARP-GEO\_GA-1415\_XX\_01-DR-CR-0012 (Rev L01)

*Summary:* It is unclear if there will be sufficient space within the Nutley Lane/Merrion Road signalised junction to accommodate the swept path of HGVs and buses, particularly where adjacent turning lanes receive a green signal during the same phase.

Information regarding the swept path of vehicles undertaking turning movements at proposed signalised junctions within the Scheme have not been provided to the Audit Team. The Audit Team are concerned that there will not be sufficient space at all junctions to accommodate the swept path of all vehicles, particularly HGVs and buses, within the proposed junction layouts. This is a particular concern where adjacent turning lanes proceed simultaneously on one phase as drivers may encroach within the path of an adjacent vehicle resulting in low-speed side-swipe collisions.

Additionally, this problem may be exacerbated where left turners from Nutley Lane proceed within the same phase as right turners from Merrion Road.

A comprehensive swept path analysis should be undertaken to demonstrate that all new, and revised, signalised junctions can sufficiently accommodate the swept path of all vehicles. Where constraints are identified, the layout should be revised to ensure all vehicle movements can be accommodated.

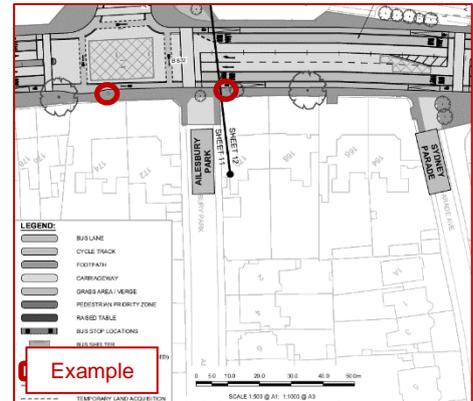
*Summary: Heritage features indicated within the footpath and cycle track may present obstacles to pedestrians and cyclists.*

A number of Heritage Features within the footpath and cycle track have been indicated as being retained throughout the project. It is unclear from the drawings provided what these features are and whether they will result in significant obstacles to pedestrians and cyclists.

Large features within the footpath and cycle track may also reduce the effective width of the footpath and cycle track which may lead to VRUs having to step into the cycle track, from the footpath, or adjacent carriageway to allow oncoming VRUs to pass resulting in an increased risk of being struck by a vehicle or cyclist.

Ensure the retained Heritage Features do not present obstacles to pedestrians and cyclists.

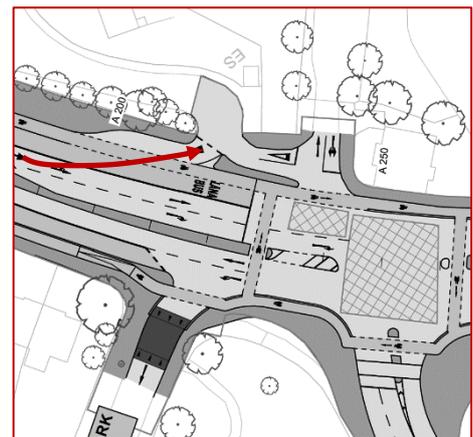
*Location: BCIDC-ARP-GEO\_GA-1415\_XX\_01-DR-CR-0001 (Rev L01)*

*Summary: Limited visibility to cyclists may lead to side-on and side-swipe collisions.*

Westbound vehicles wishing to access St Vincent’s Park must cross a Bus Lane and a cycle lane to access the left lane diverge/yield. The angle of approach may be such that visibility is limited for left turners, leading to side-swipe and side-on collisions with cyclists.

This problem may be exacerbated by a sense of urgency where drivers attempt to turn left ahead of a following bus, which may lead to a driver being less focussed on a cyclist.

Left turning traffic should merge with the bus lane upstream of the side road access.

Alternatively, the left turn diverge should be removed, with left turns being incorporated within the signalised junction. This approach may also simplify pedestrian movement through the junction, which is currently unclear.

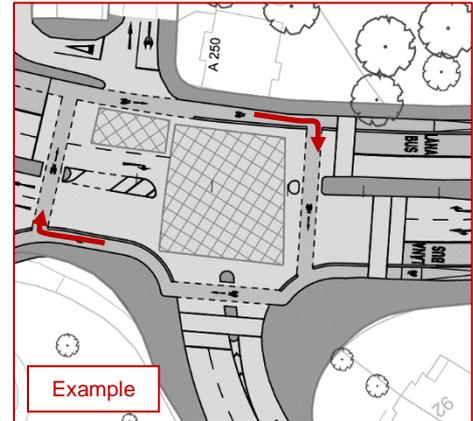
*Summary: Right turning cyclists may impede straight-ahead cyclist movement, leading to rear-end-shunt and side-swipe collisions.*

Cyclists waiting to turn right at signalised junctions will likely wait within the cycle track until they are given a green signal. However, the space within the cycle track is limited, so waiting cyclists may impede straight-ahead cycle movement, increasing the risk of rear-end-shunt collisions with following cyclists, or force cyclists to enter the footway or carriageway to continue around the stationary cyclists, leading to cyclist/pedestrian collisions, or side-swipe collisions with buses.

Stationary cyclists should be provided with space to wait, which is outside the path of straight-ahead cyclists.

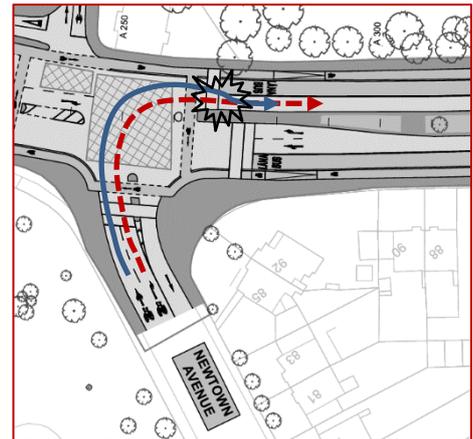
*Location: BCIDC-ARP-GEO\_GA-1415\_XX\_01-DR-CR-0001  
(Rev L01)*

*Summary: Two right turn lanes in Newtown Avenue do not correspond with one single lane on Temple Hill and may lead to side-swipe collisions as drivers quickly attempt to exit the bus lane.*

Newtown Avenue is indicated as having two lanes ('left/straight/right' in the nearside lane and 'right only' in the offside lane). Temple Hill's westbound carriageway has a bus lane and a straight-ahead lane, so cannot accept two right turning vehicles. This may lead to right turning vehicles in the nearside lane having to suddenly merge with traffic in the offside lane when they observe the bus lane, leading to side-swipe collisions.

Additionally, it is unclear if two right turning vehicles can navigate the right turn manoeuvre at the same time. Insufficient width may lead to side-swipe collisions before entering Temple Hill.

The nearside traffic lane on Newtown Avenue should be left and straight-ahead only.

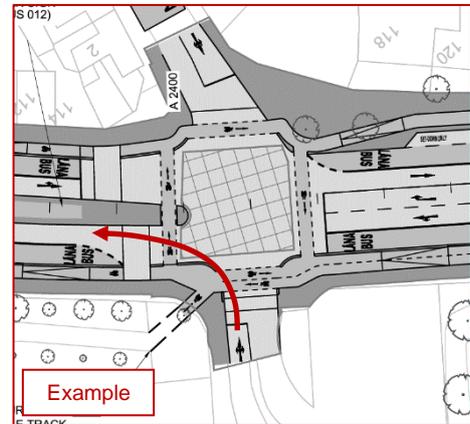
*Example: BCIDC-ARP-GEO\_GA-1415\_XX\_01-DR-CR-0007 (Rev L01)*

*Summary: It is unclear if there will be sufficient space within the signalised junction to accommodate the swept path of all vehicles.*

Information regarding the swept path of vehicles undertaking turning movements at proposed signalised junctions within the Scheme have not been provided to the Audit Team. The Audit Team are concerned that there will not be sufficient space at all junctions to accommodate the swept path of all vehicles, particularly HGVs and buses, within the proposed junction layouts. This is a particular concern where protected cycle lane infrastructure reduces the turning radii further.

A comprehensive swept path analysis should be undertaken to demonstrate that all new, and revised, signalised junctions can sufficiently accommodate the swept path of all vehicles. Where constraints are identified, the layout should be revised to ensure all vehicle movements can be accommodated.

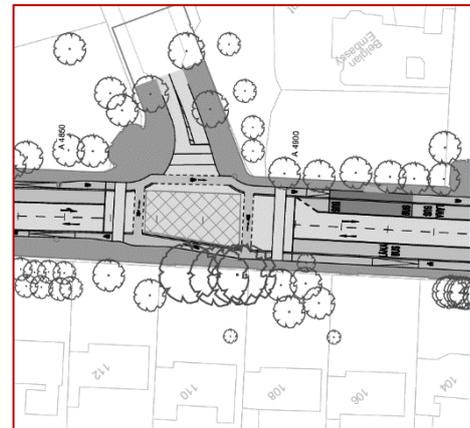
*Location: BCIDC-ARP-GEO\_GA-1415\_XX\_01-DR-CR-0014 (Rev L01) and BCIDC-ARP-GEO\_GA-1415\_XX\_01-DR-CR-0020 (Rev L01)*

*Summary: Road narrowing may lead to side-swipe collisions.*

Road users travelling east on Merrion Road may be unaware of the road narrowing at Shrewsbury Road, which will require buses to merge with general traffic. The relatively short merge length through the junction may lead to unsafe merging and side-swipe collisions, particularly during a green signal phase.

A similar concern exists at the junction of Baggot Street Lower and Herbert Place.

Provide appropriate signage to warn drivers of the road narrowing in good advance of the signalised junction.

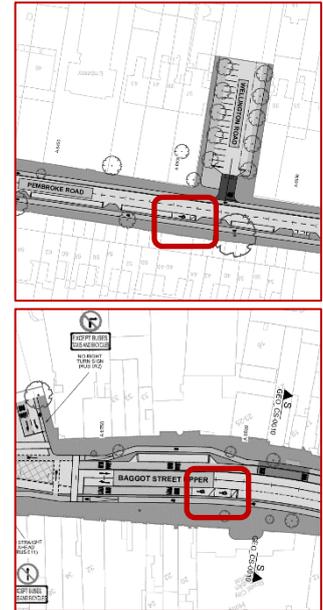
*Location:* BCIDC-ARP-GEO\_GA-1415\_XX\_01-DR-CR-0018 (Rev L01) and BCIDC-ARP-GEO\_GA-1415\_XX\_01-DR-CR-0019 (Rev L01)

*Summary:* Insufficient width of mobility parking space may increase the risk of mobility users conflicting with moving traffic, leading to serious personal injury.

Parking space dimensions have not been provided to the RSA Team at this early stage in the design process, so the width of parking spaces is unknown. However, the mobility parking spaces on Pembroke Road and Baggot Street appear to share the same width as adjacent parking spaces, despite needing additional width to accommodate users getting in and out of their vehicles. Insufficient width for mobility users may increase the risk of personal injury should a user be struck by a moving vehicle when accessing/exiting their vehicle.

Ensure the width of mobility parking spaces is compliant with the Traffic Signs Manual.

Additionally, ensure dropped kerbs and tactile paving is provided at each mobility parking space to support access between the parking space and the footway.

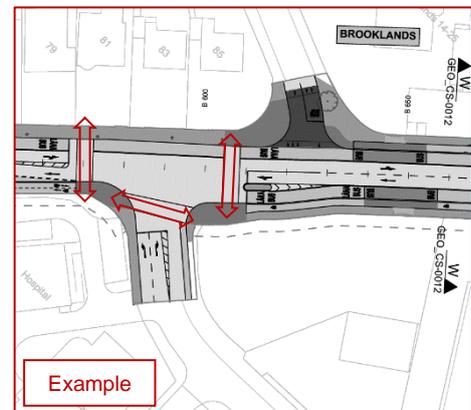
*Example:* BCIDC-ARP-GEO\_GA-1415\_XX\_01-DR-CR-0023 (Rev L01)

*Summary:* Unclear if the crossings within signalised junctions will be Toucan crossings to allow cyclists to cross to other cycle facilities on the opposite side of the junction.

At a number of junctions within the Scheme, off-road cycle tracks are indicated as terminating upstream/at what is assumed to be a shared surface at the crossings within the junction. The Audit Team assume that cyclists wishing to access other arms of these junctions, where cycle facilities are not incorporated into the junction, will do so by using the signalised crossings in the junction.

It is unclear if these crossings will be Toucan crossings. If these crossings are not toucan crossings there is a risk that the crossing will not be sufficiently wide enough to safely accommodate pedestrians and cyclists and will not provide measures (separate push button/signal head) for cyclists. This could lead to an increased risk of conflicts between pedestrians and cyclists when accessing, waiting at, and using the crossing.

Ensure all crossings at shared surfaces throughout the Scheme are Toucan crossings with a minimum width of 4m.

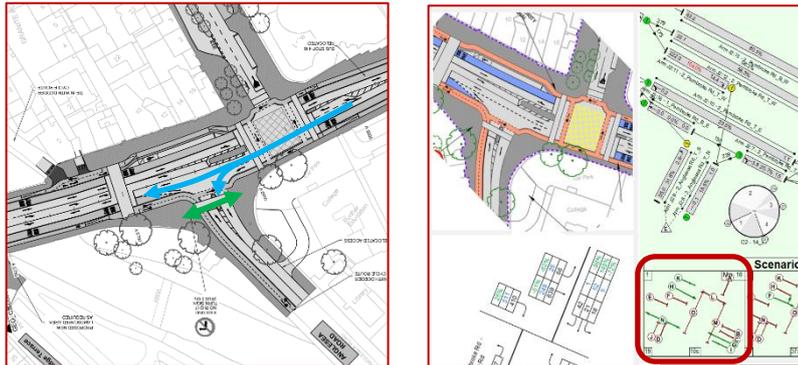
*Location: BCIDC-ARP-GEO\_GA-1415\_XX\_01-DR-CR-0016 (Rev L01)*

*Summary: Left turning traffic on Merrion Road is permitted access to Anglesea Road at the same time as the pedestrian stage for pedestrians crossing Anglesea Road, which may lead to pedestrian/vehicle collisions.*

The phasing diagram provided at the Merrion Road/Anglesea Road junction indicates that the pedestrian crossing of Anglesea Road shall share the same phase as the straight-ahead and left-turning movements on Merrion Road, which will bring pedestrian crossing movements into conflict with left turning movements from Merrion Road. This may increase the risk of a vehicle/pedestrian collision.

The pedestrian and vehicle phase should be separated.

A thorough review of each signal phasing diagram should be undertaken to ensure further conflicting movements are avoided across the project.

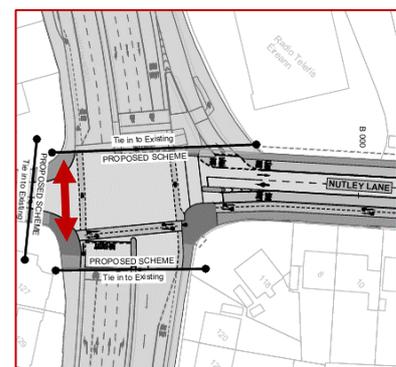
*Location: BCIDC-ARP-GEO\_GA-1415\_XX\_01-DR-CR-0022 (Rev L05)*

*Summary: Lack of pedestrian facilities on Greenfield Park may lead to vehicle/pedestrian collisions.*

The provision of a high-quality bus corridor on Nutley Lane may increase the number of local residents choosing public transport when commuting to work, school or college. This growth will likely place increased demand on the existing pedestrian facilities on, or near, the new bus corridor. This may include residents from Stillorgan Road and Greenfield Park. However, there is currently no signalised pedestrian crossing on Greenfield Park. Pedestrians, particularly visually and mobility impaired pedestrians, traveling on Stillorgan Road (western side) and Greenfield Park (southern side) may find it difficult to navigate the crossings on route to the improved bus facilities, increasing the risk of vehicle/pedestrian collisions.

A signalised pedestrian crossing on Greenfield Park should be incorporated into signalised junction, including dropped kerb and tactile paving.

Should this be outside the scope of this project, the Designer shall bring this to the attention of the Local Area Engineer for review and consideration.

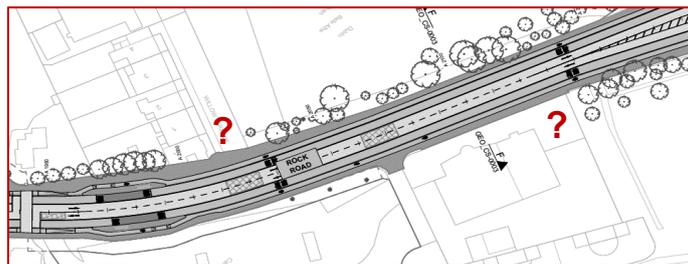
- 4.2 It is unclear if the widths of the two-way cycle track on Nutley Lane will be sufficient to accommodate two-way cyclists. The National cycle manual recommends a minimum of 2m wide lanes in each direction for a two-way cycle track.
- 4.3 Existing accesses on Rock Road have not been indicated in the design drawing (e.g. kerb, gap in cycle track kerb etc) for Willow Terrace and the Carpark/Dealership.

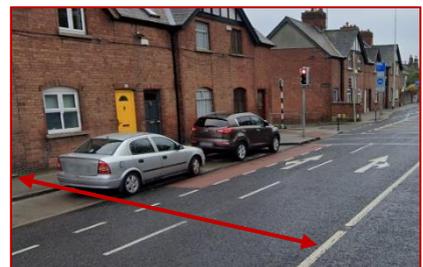
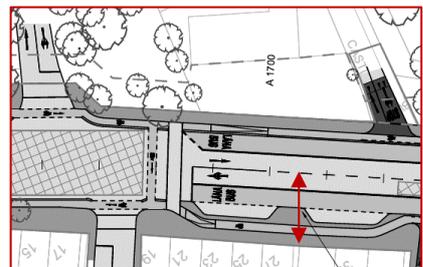
- 4.4 The existing cross section on the eastbound Rock Road carriageway includes a pedestrian footway, parallel parking, a nearside traffic lane (that includes an advisory cycle lane within it) and an offside traffic lane.

The proposed layout indicates a cross section that includes a pedestrian footway, an off-road cycle track, a buffer zone, parallel parking, a nearside bus lane and an offside traffic lane.

In the absence of dimensions, it is unclear to the RSA Team if the proposed layout can fit within the existing footprint. Ensure the proposed cross section can be accommodated within the available footprint.

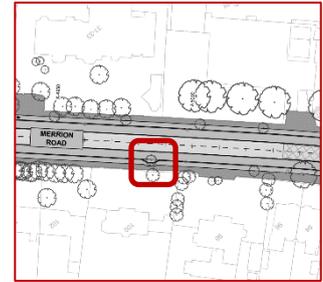
- 4.5 It is proposed to retain a tree on the northern side of Merrion Road where a cycle lane is proposed. This will result in a sharp and short deflection on the cycle track, as well as an increased risk of tree roots deforming the cycle lane surface. The tree should be removed from the footway.
